## Bearing upgrade project completed

The project involved upgrading the journal bearings on a Westinghouse 251 B gas turbine. The gas turbine operates at 4,894 RPM and drives a 2-pole (3,600 RPM) generator through a gear box. The turbine is located at an electric utility power plant in the Midwest.

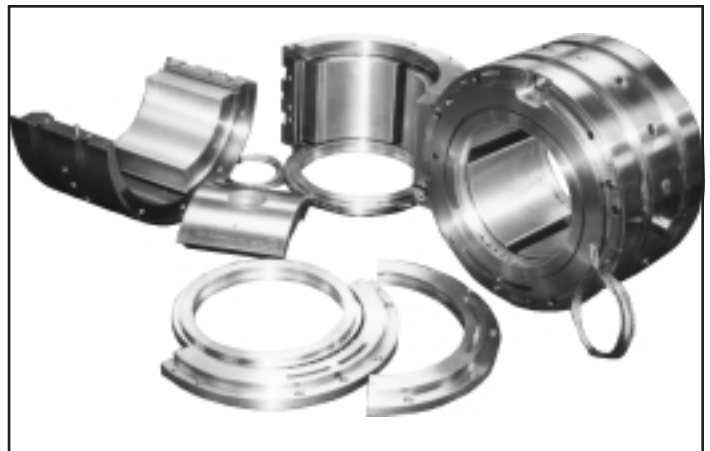
**FIGURE 1, above, shows the tilting pad bearings delivered five weeks after the order. Figure 2, below, shows the OEM bearing.**

In early 1999, TCE received an order to manufacture a set of two 9” tilting pad bearings of the four pad design. Delivery was required in a short five weeks. The bearings were delivered during the first week in March and the shipment coordinated with the repaired rotor leaving the repair shop at the same time. The bearings are shown in Figure 1.

1997, the unit was so rough it could not be run safely on a continuous basis. With the upgraded bearing design maximum vibration reached 2.0 mils peak to peak at the first critical and less than 1.0 mil at 15 MW. The journal bearing babbitt metal temperatures are now satisfactory, running well below 200F.
